THI Premium Home Inspection Report

2425 Anywhere Dr
Nashville, TN 37206

Prepared for: Happy Client

Prepared by: Tennessee Home Inspectors LLC

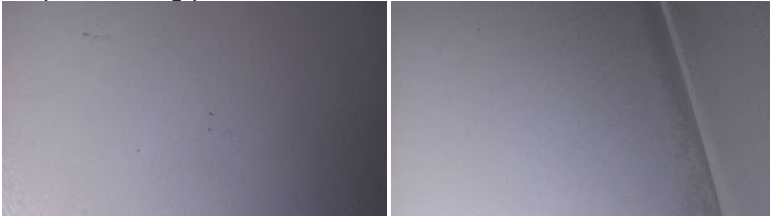
5. Repair - Siding paint was observed to be thin. Additional coats are recommended.

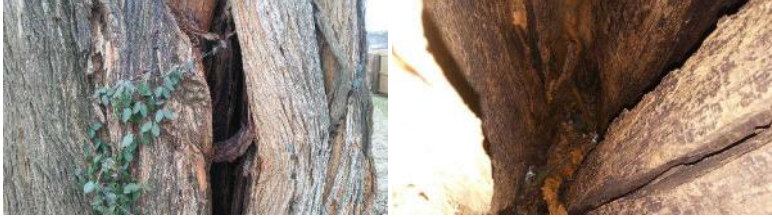
13. Repair - The tree in the back yard is damaged and hollow in the center. An arborist should evaluate for health and viability of the tree. Branch trimming or removal may be required.

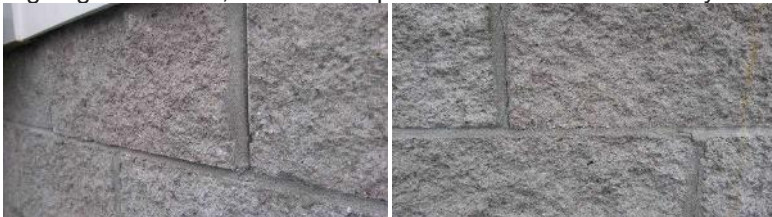
14. Repair - Minor foundation cracks were observed at the front corner. This implies that some settlement of the building or seasonal expansion has occurred. Cracks of this type should be filled and monitored. In the absence of evidence of ongoing movement, structural repair should not be necessary.

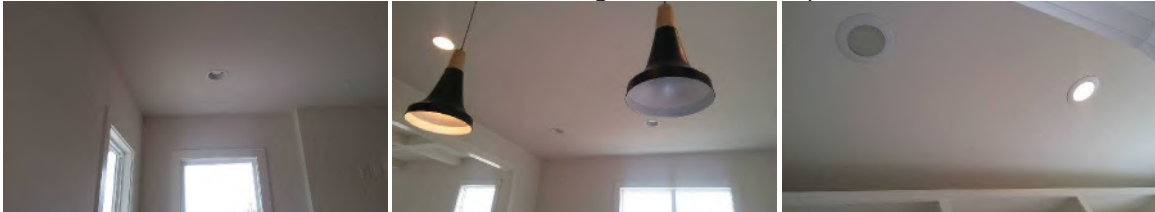
24. Repair - The light switch was located behind the door when entering the laundry room. This is inconvenient and the switch should be moved and be operable upon entry without closing the door.
25. Repair - The light was inoperable at the living room, front bedroom closet, and kitchen island. The bulb should be replaced. If the bulb is not blown, the circuit should be investigated and made operable.
