THI Sure Shot Home Inspection Report

2824 Anywhere Ave
Nashville, TN 37219

Prepared for: Happy Client

Prepared by: Tennessee Home Inspectors LLC

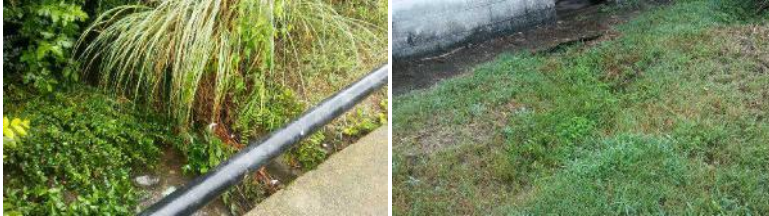
Consult - The house was in close proximity to a creek. Geological surveys and flood history or potential are outside the scope of this inspection.

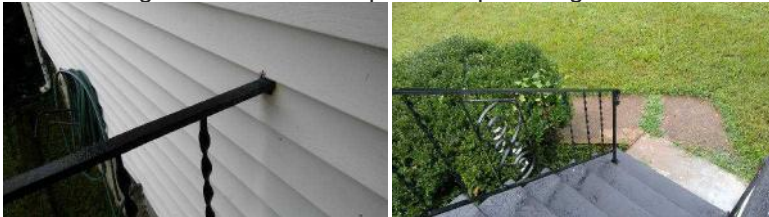
Repair - Loose railing was observed at porch steps railing.

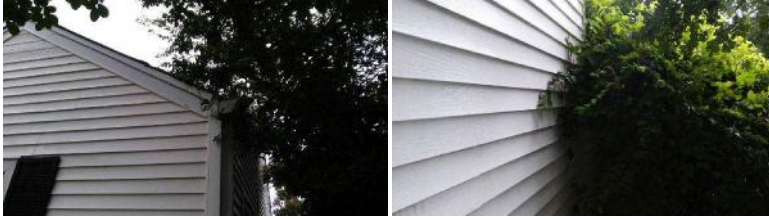
Repair - Bush branches were observed to be in close proximity or touching the home.

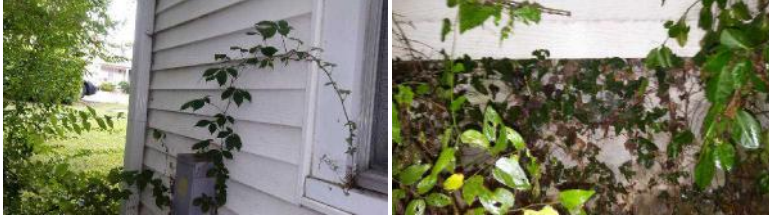
Repair - Vines were observed growing on exterior walls.

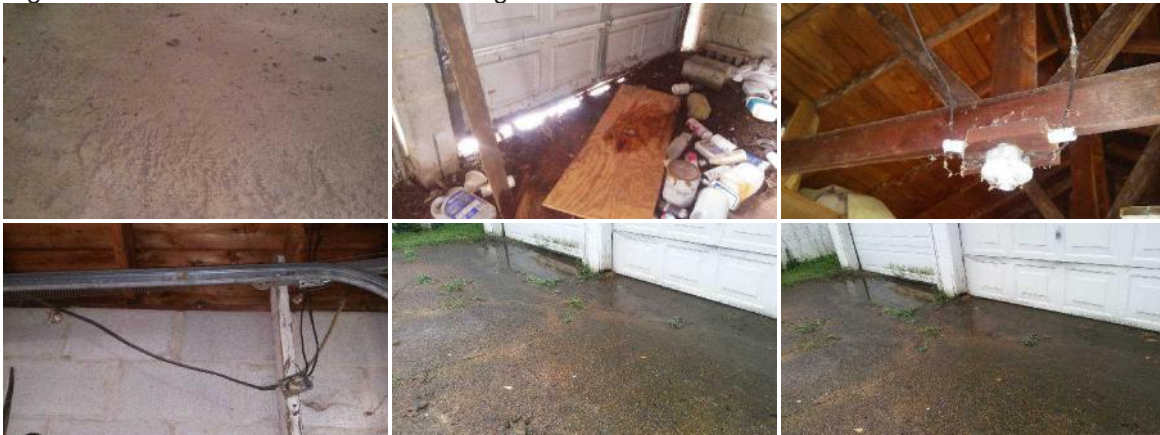
Repair - Signs of water intrusion into the outbuilding were observed.

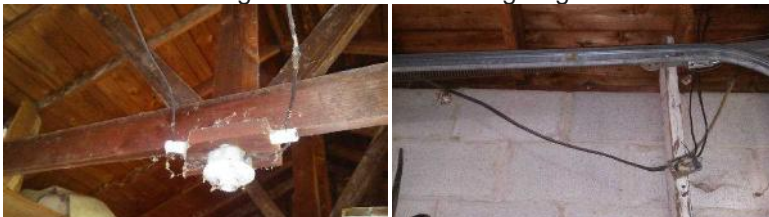
Repair - Knob and tube wiring was observed in the garage.

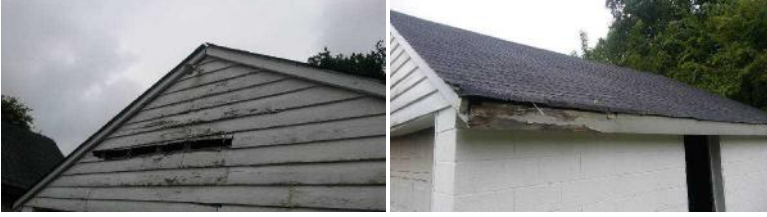
Repair - Damaged siding, roofing and missing gutters were observed at the outbuilding.

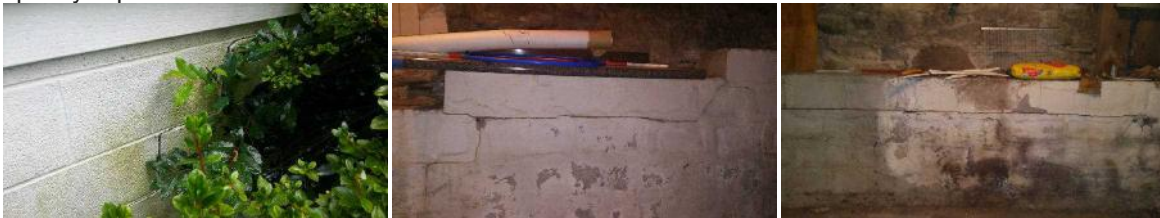
Repair - A significant foundation crack was observed. This implies that some structural movement of the building has occurred. . A licensed structural engineer should be contacted to review and approve this issue as is in writing or specify repairs.

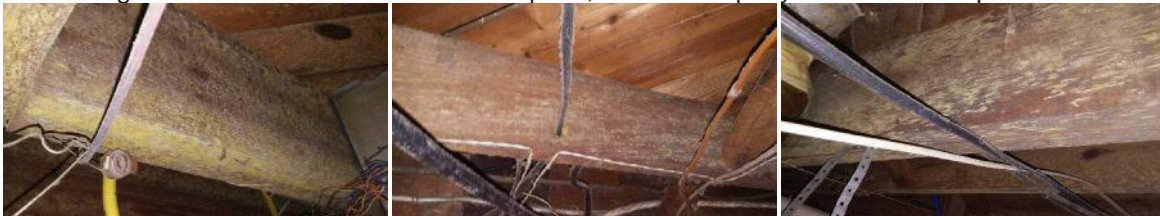
Repair - Microbial growth was observed in the crawl space, located in spotty areas of the exposed floor structure.

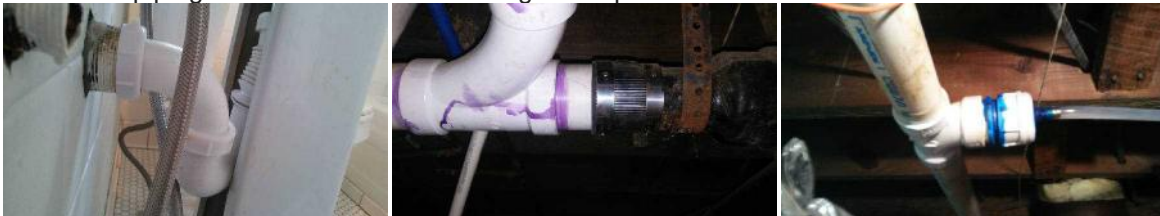
Repair - The waste piping was observed to be leaking at the pedestal sink and basement.

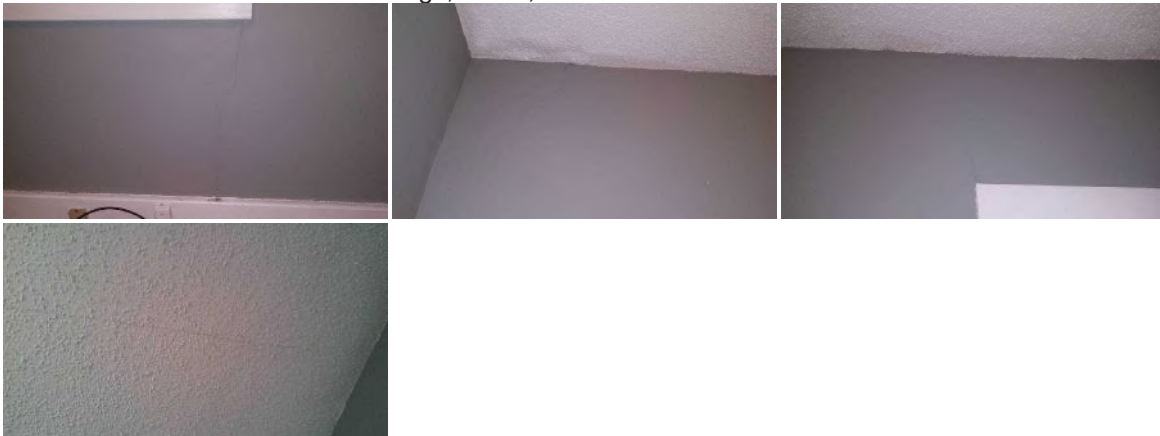
Repair - Wall cracks were observed at ceilings, doors, and windows.
