# THI Sure Shot Home Inspection Report

2024 Anywhere Dr  
Nashville, TN 37216

Prepared for: Happy Client

Prepared by: Tennessee Home Inspectors LLC

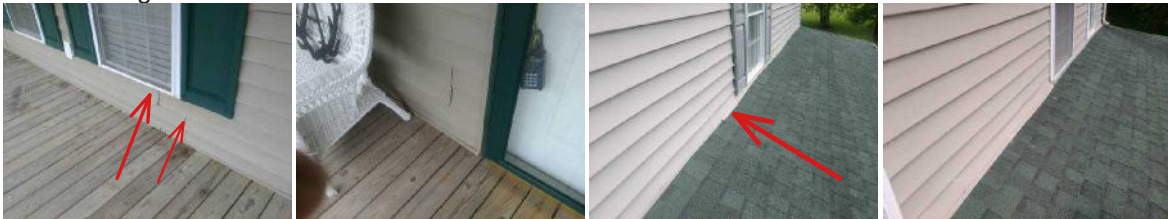
**Repair -** Loose siding was observed.

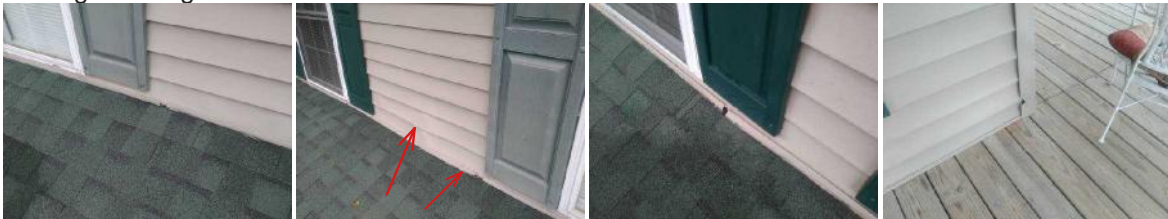
**Repair -** Damaged siding was observed.

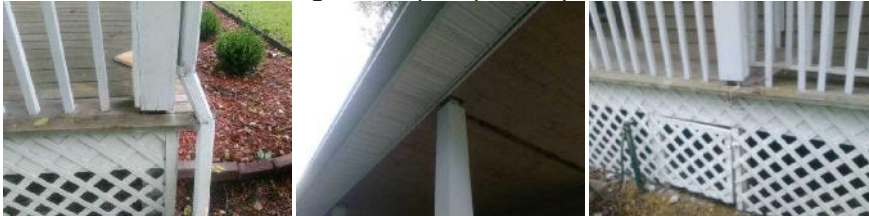
**Repair -** Trim was observed missing in multiple spots of post

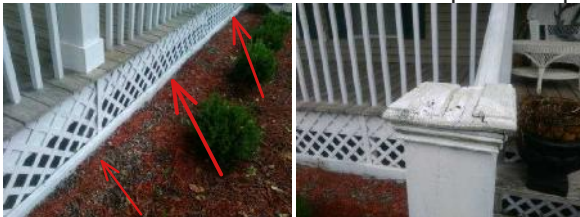
**Repair -** rotted wood was observed on the wrap around porch.

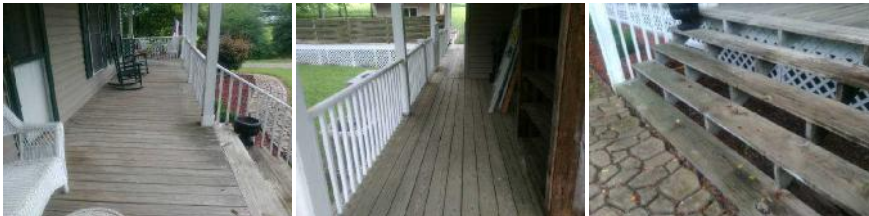
**Repair -** The deck surface was unfinished or deteriorated.

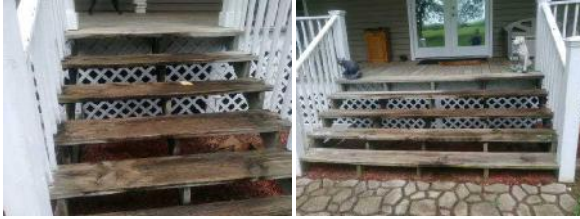
**Repair -** Deck steps show signs of deterioration

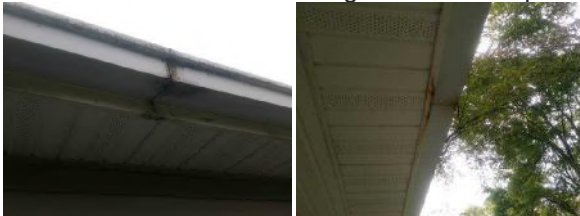
**Repair -** Leaks were observed in the gutters. In multiple locations around home

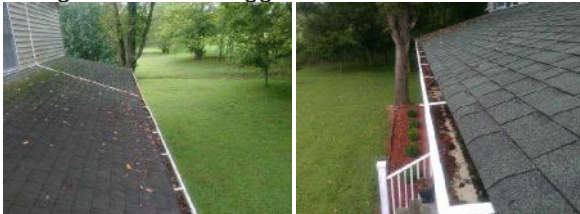
**Repair -** The gutters were clogged.

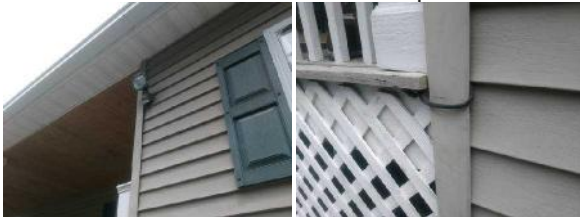
**Repair -** Extension cords were observed as permanent electrical wiring.

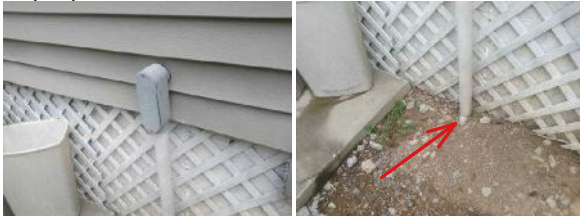
**Repair -** Improper and loose electrical connections were observed.

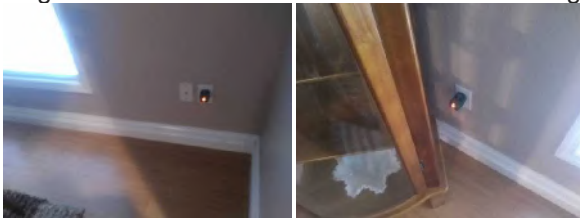
**Repair -** Ungrounded outlets were observed in the dining room.

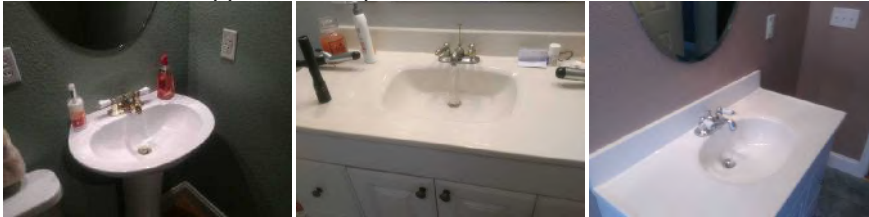
**Repair -** The sink drain stopper was inoperable. Downstairs hall bath

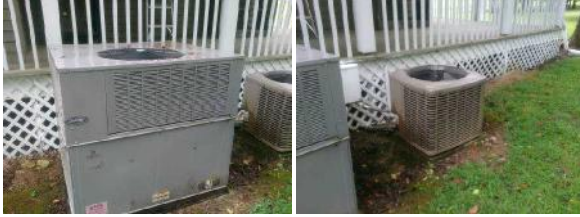
**Repair -** The outdoor condensing unit of the air conditioning system were dirty.

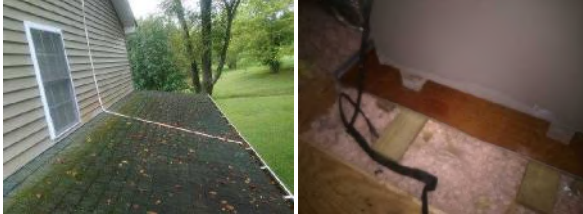
**Repair -** HVAC condensation drain drains into gutter on top of house

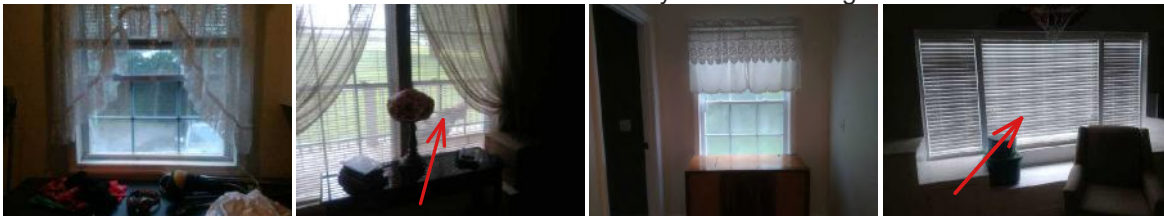
**Repair -** Condensation or haziness was observed between the layers of window glass at several locations.

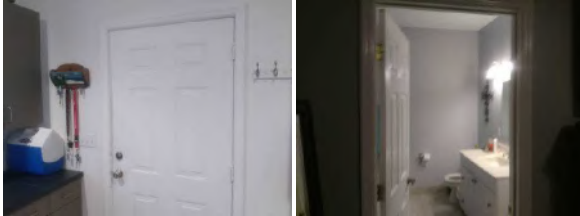
**Repair -** Doors were observed to rub or contact each other.

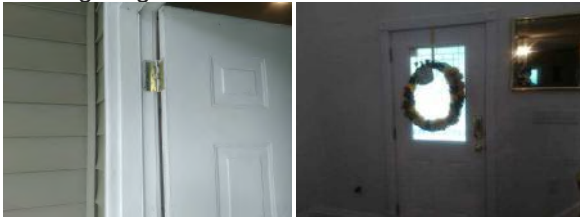
**Repair -** Missing hinge screws were observed.
