# THI Sure Shot Home Inspection Report

2024 Anywhere Dr  
Goodlettsville, TN 37072

Prepared for: Happy Client

Prepared by: Tennessee Home Inspectors LLC

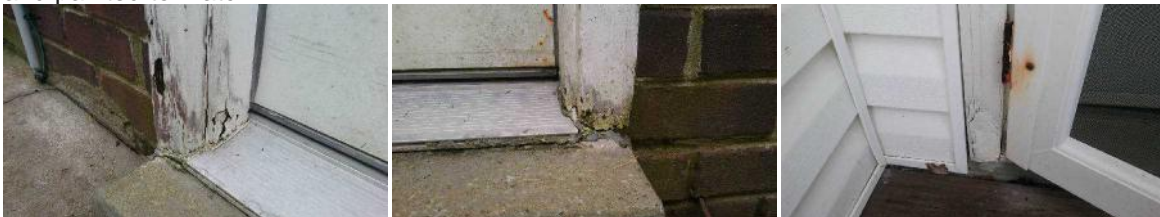
**Repair -** Localized evidence of rot was visible at door trim. Rotted wood should be replaced, prepped, caulked at gaps, and painted to match.

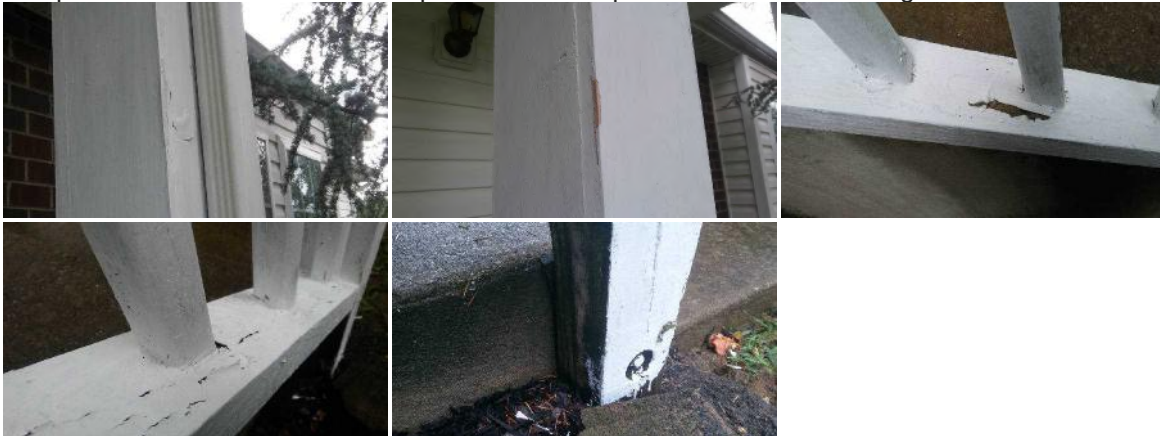
**Repair -** The paint finish was insufficient in spots of the front porch columns and railings.

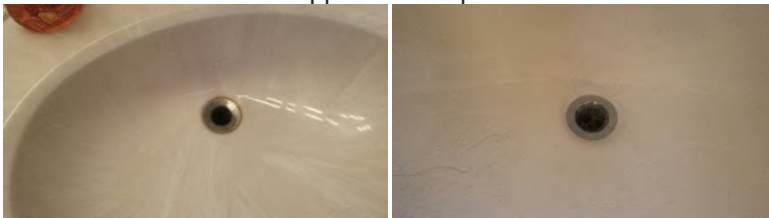
**Repair -** The sink and tub drain stopper was inoperable in master bathroom.

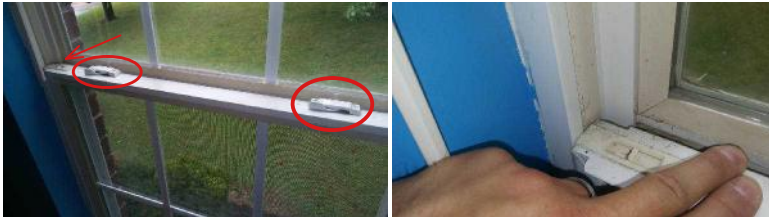
**Repair -** Window could not be shut fully at time of inspection and window locks would not engage. The left side guide latch was also broken.

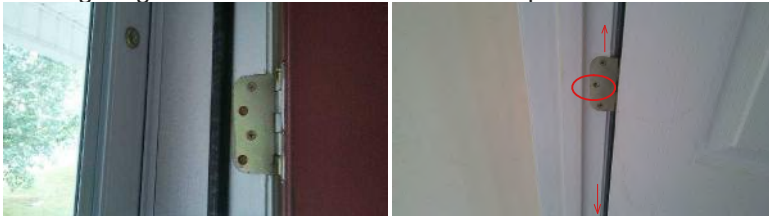
**Repair -** Missing hinge screws were observed in multiple locations.

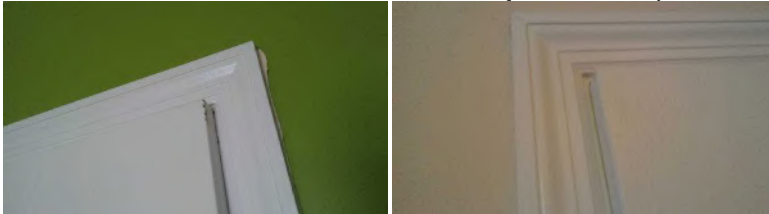
**Repair -** Doors were observed to rub or contact the jamb in multiple locations.

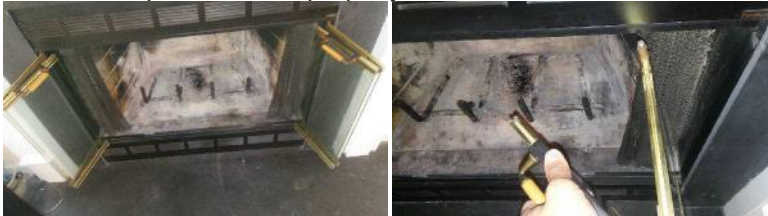
**Repair -** Doors in fireplace are not properly mounted.
