THI Sure Shot Home Inspection Report

2024 Anywhere Dr
Nashville, TN 37216

Prepared by: Tennessee Home Inspectors LLC

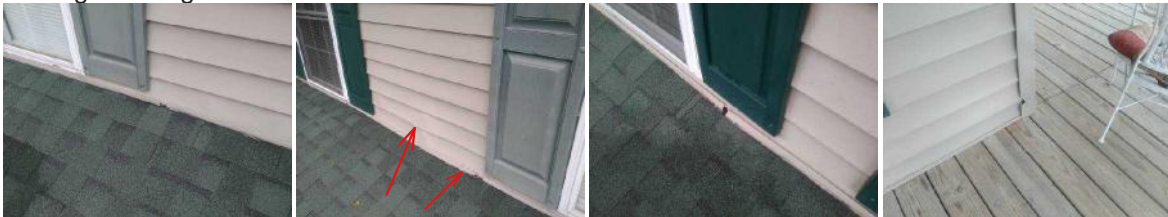
Repair - Damaged siding was observed.

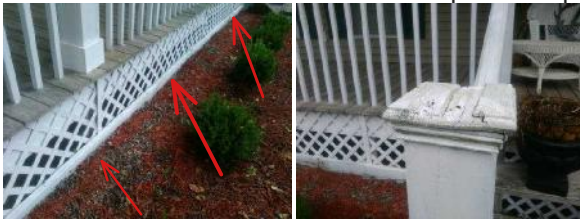
Repair - rotted wood was observed on the wrap around porch.

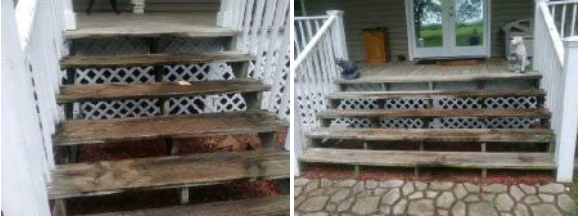
Repair - Deck steps show signs of deterioration

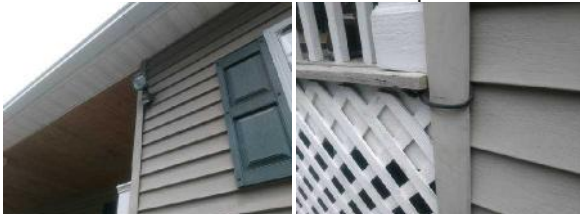
Repair - Extension cords were observed as permanent electrical wiring.

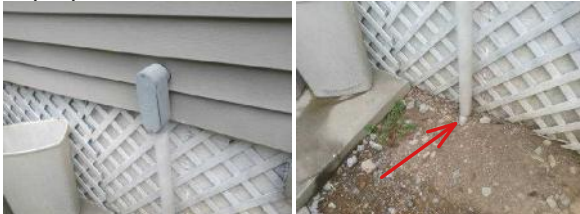
Repair - Improper and loose electrical connections were observed.

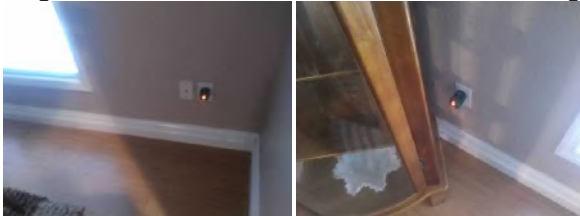
Repair - Ungrounded outlets were observed in the dining room.

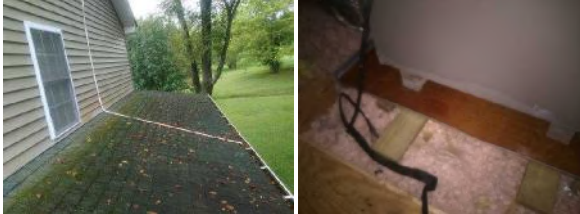
Repair - HVAC condensation drain drains into gutter on top of house

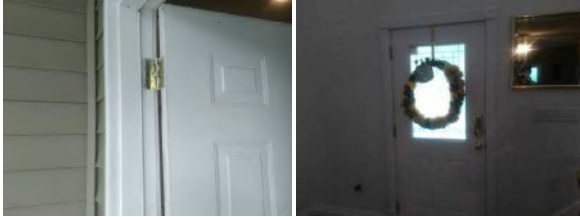
Repair - Missing hinge screws were observed.
