THI Sure Shot Home Inspection Report

2024 Anywhere Dr
Goodlettsville, TN 37072

Prepared for: Happy Client

Prepared by: Tennessee Home Inspectors LLC

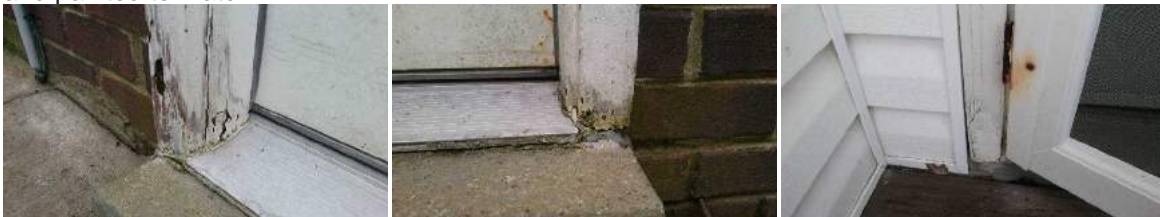
Repair - Localized evidence of rot was visible at door trim. Rotted wood should be replaced, prepped, caulked at gaps, and painted to match.

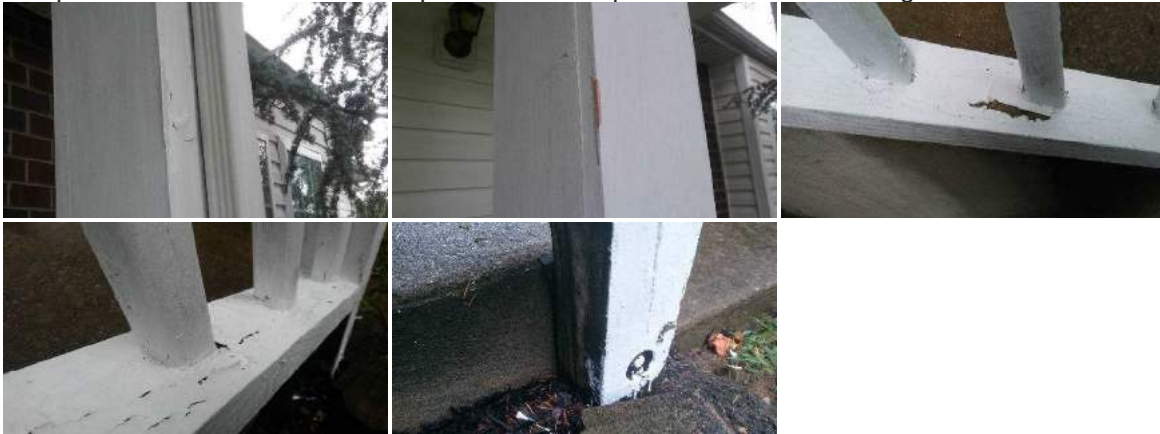
Repair - The paint finish was insufficient in spots of the front porch columns and railings.

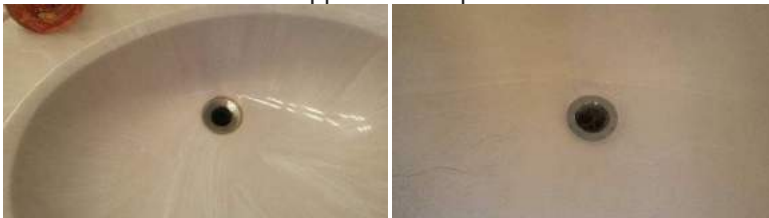
Repair - The sink and tub drain stopper was inoperable in master bathroom.

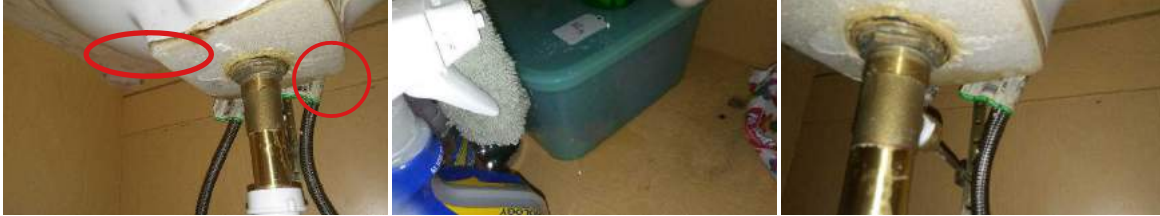
Repair - Bathroom sink leaked from the ceramic joints.

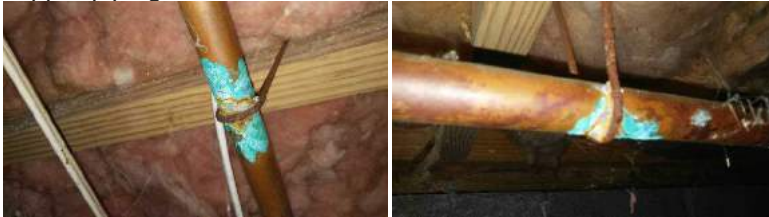
Repair - Improper support of supply water piping was observed in multiple locations in the crawl space. Steel hangers with copper piping. Dissimilar metals do not react well to each other.

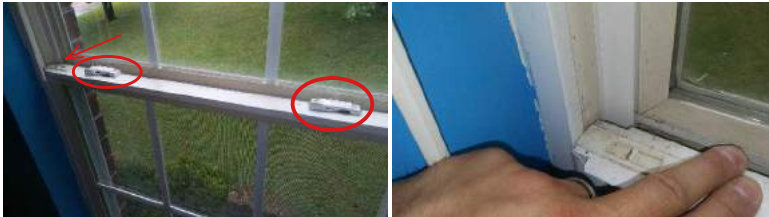
Repair - Window could not be shut fully at time of inspection and window locks would not engage. The left side guide latch was also broken.

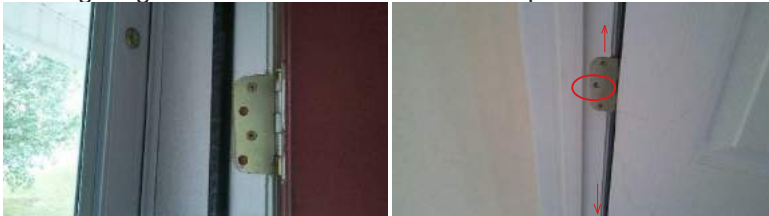
Repair - Missing hinge screws were observed in multiple locations.

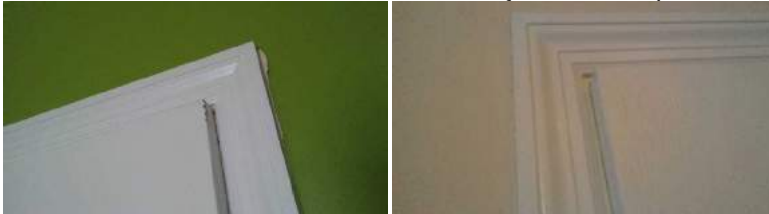
Repair - Doors were observed to rub or contact the jamb in multiple locations.

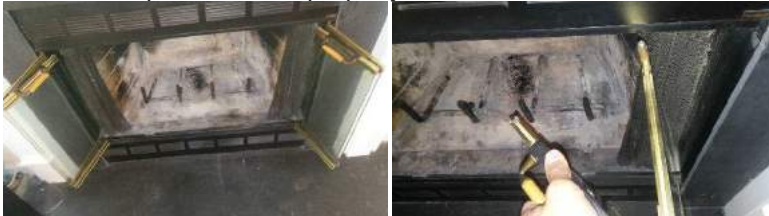
Repair - Doors in fireplace are not properly mounted.
